# JACKAROO 3000 TURBO DIESEL

## Diagnostic Trouble Codes P1485/P1486

### Flash Code 74 – ITP Failure.

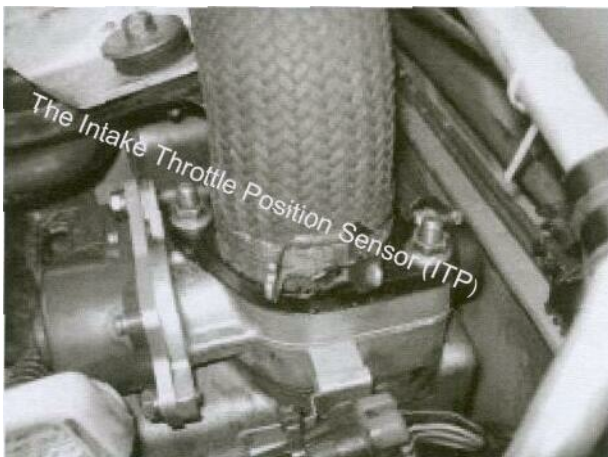
The ITP is an electrical potentiometer on the rear (firewall) end of the throttle shaft. On the other end is the throttle motor.

As the accelerator pedal is depressed, the stepper twists the shaft opening the throttle. The ITP reports the throttle position to the ECM, which then adjusts the fuel mixture.

The actual ITP failure occurs as the wiper arm wears through the track and this, coupled with the gradual ingress of unburned fuel through from the throttle shaft bearing, results in irregular resistance of the potentiometer.

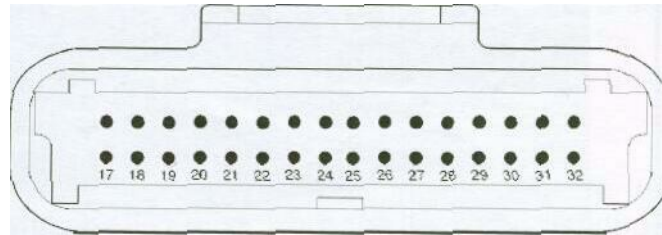
**ECM Pinout Table, 32-Way Connector - J1 RED - Lower**

The grey/black wire terminates on pin 18 of J1.

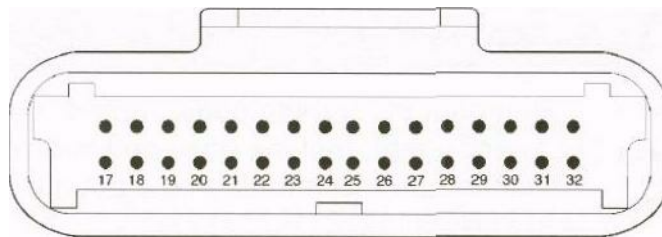
**ECM Pinout Table, 32-Way Connector - J2 BLUE - Lower**

The black/white wire terminates on pin 26 of J2.
